Christchurch Central Business District Cycle Signal Safety Audits

Alex Lumsdon | Beca | Peloton – Senior Transportation Engineer

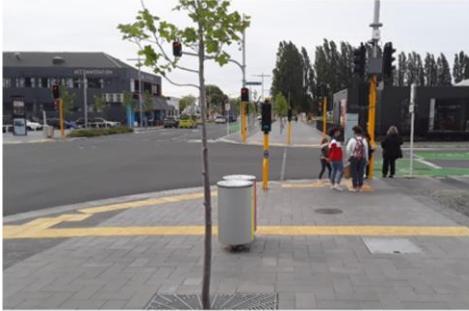
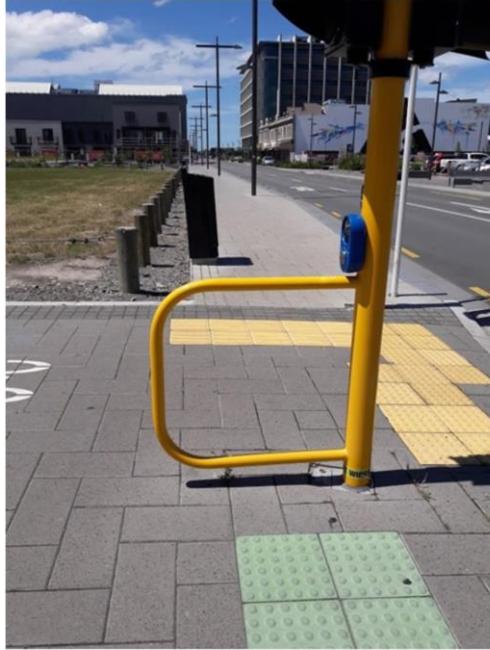
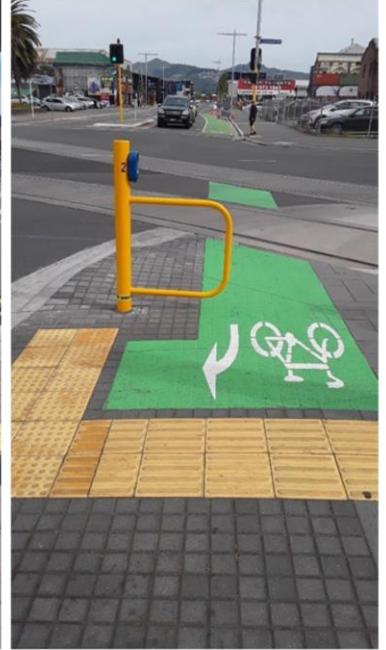
Poles & Handrails

- Alignment of poles with the crossing
- Pole foundations
- Handrails restricting shared footpaths
- Manoeuvrability for cyclists

Replace type 11 poles with standard type 1 signal poles and install the cycle aspects higher to remove the potential for cyclists to conflict with the aspects. Confirm if cycle handrails are needed or whether they are creating extra obstacles for cyclists to negotiate

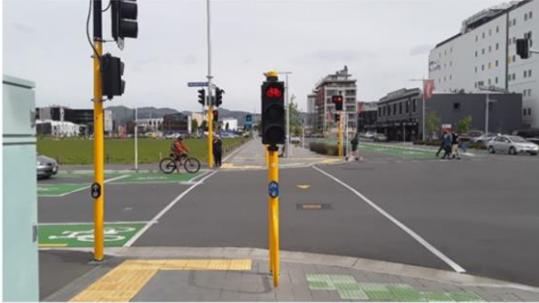
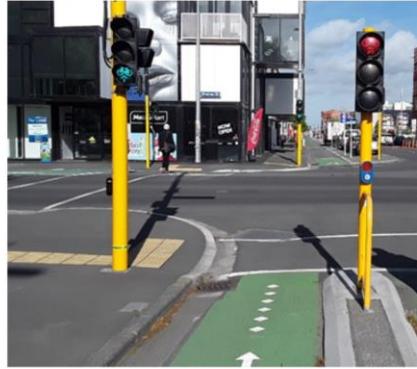
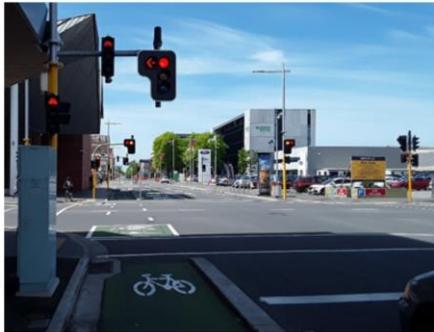
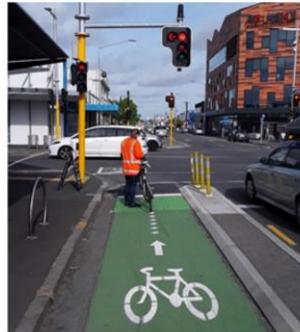
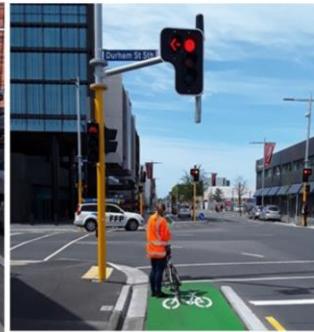
Low Level Signal Lanterns

- Identified locations where Type 11 cycle poles have been installed
- Risk of users potentially head striking low level cycle lanterns
- Identifying Type 10 cycle mast arm pole locations
- Undertaking a review of signal lanterns overhanging into the vehicle lanes
- No part of the signal lantern or backing board is to be closer than 300mm from the kerb face

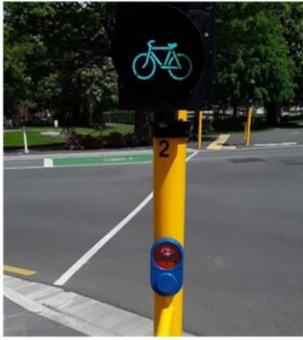
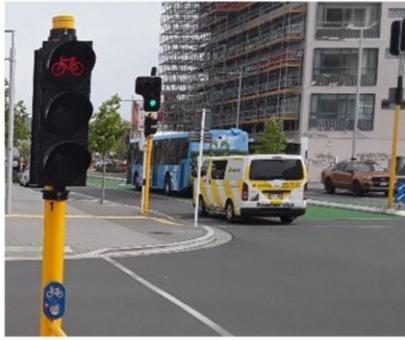
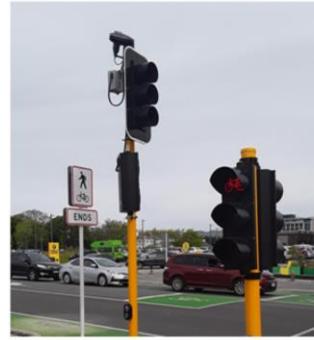
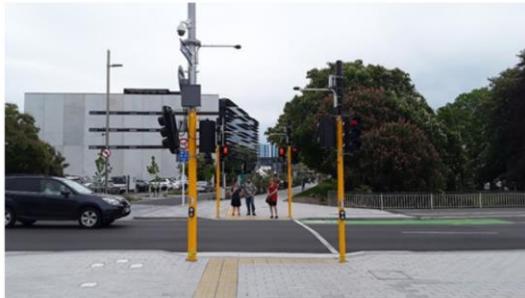
Cycle Push Buttons & Kerbside Pedestrian Detector Cameras

- Council requirement to 'fail safe' all pedestrian and cycle crossings
- Removal of existing cycle call accept units
- Installation of cycle and pedestrian demand push button units
- Kerbside detector logic and intended operation
- Detector height to maximise detection zone

Re-alignment of a ped camera, or cutting a new cycle loop

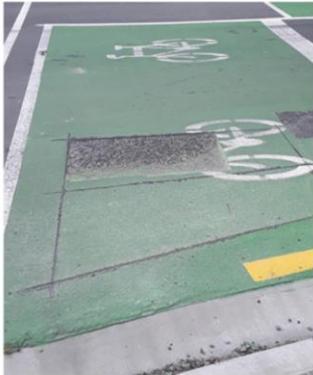
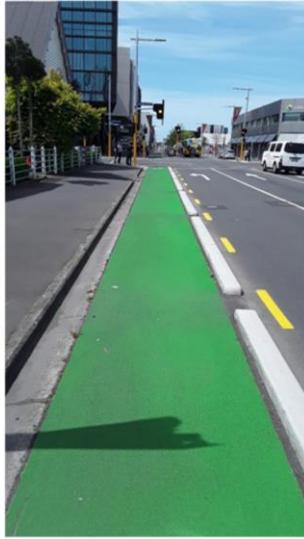
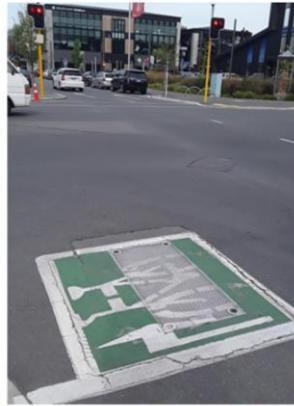
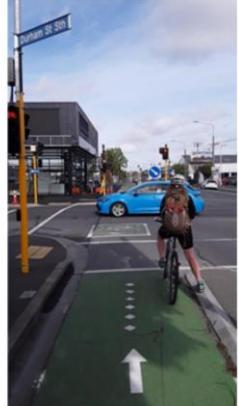
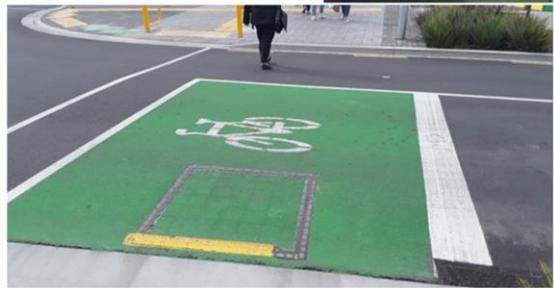
Cycle Detectors & Operation

- Incorrect loop positions
- Identification of faulty or intermittent cycle detector loops
- Adequate pavement markings to identify the position of cycle detector loops to cyclists
- Loop detector operation and logic
- Consistency with the route and adjacent intersections
- Poor loop conditions
