Traffic Signal Controller Safety Programme

Richard Humm | Christchurch City Council – Project Manager

Alex Lumsdon | Beca – Lead Quality Auditor

We are here to discuss the recent Christchurch Traffic Signal Controller Safety Audit Programme.

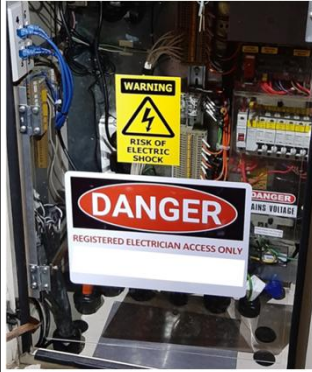
Hinged Door

1. Door hinged Perspex (preferred method)
2. Small steel rods – we requested the contractor to add protection to remove the potential conflict with the eye.
3. Full Perspex screening – this was when the controller wasn't worth upgrading and scheduled for replacement (make it safe)

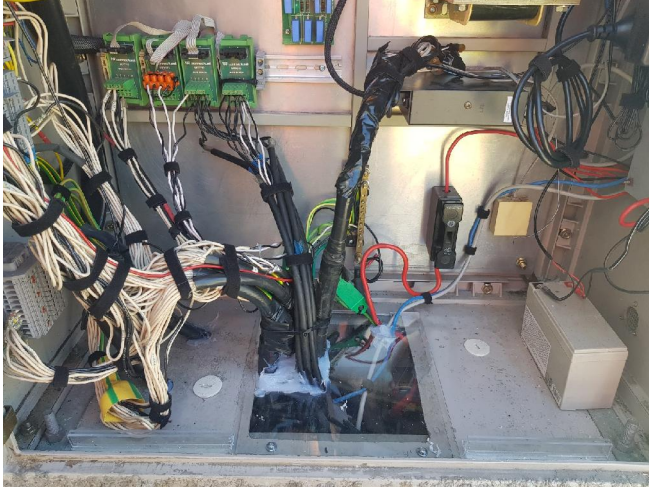
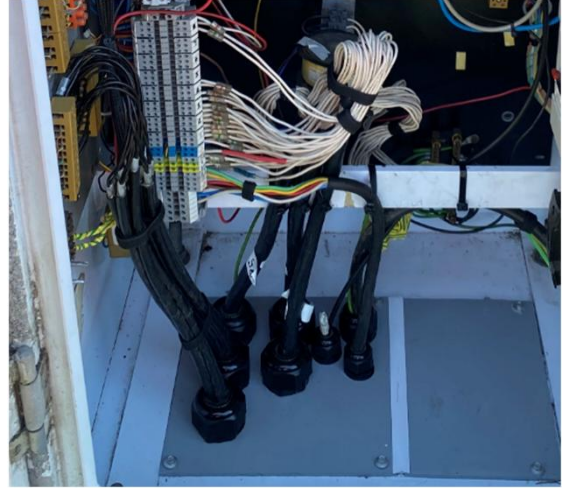
Silicone vs Sealed Glands

Although Silicone is approved to be used in P43 Traffic Signal Spec, we didn't think that this would support signal cables long-term or protect against insects or vermin. To install sealed glands signal cables were required to be disconnected, which was a significant TM cost if this was required.
