# Two Aspect Roundabout Metering Trial

Tauranga Update

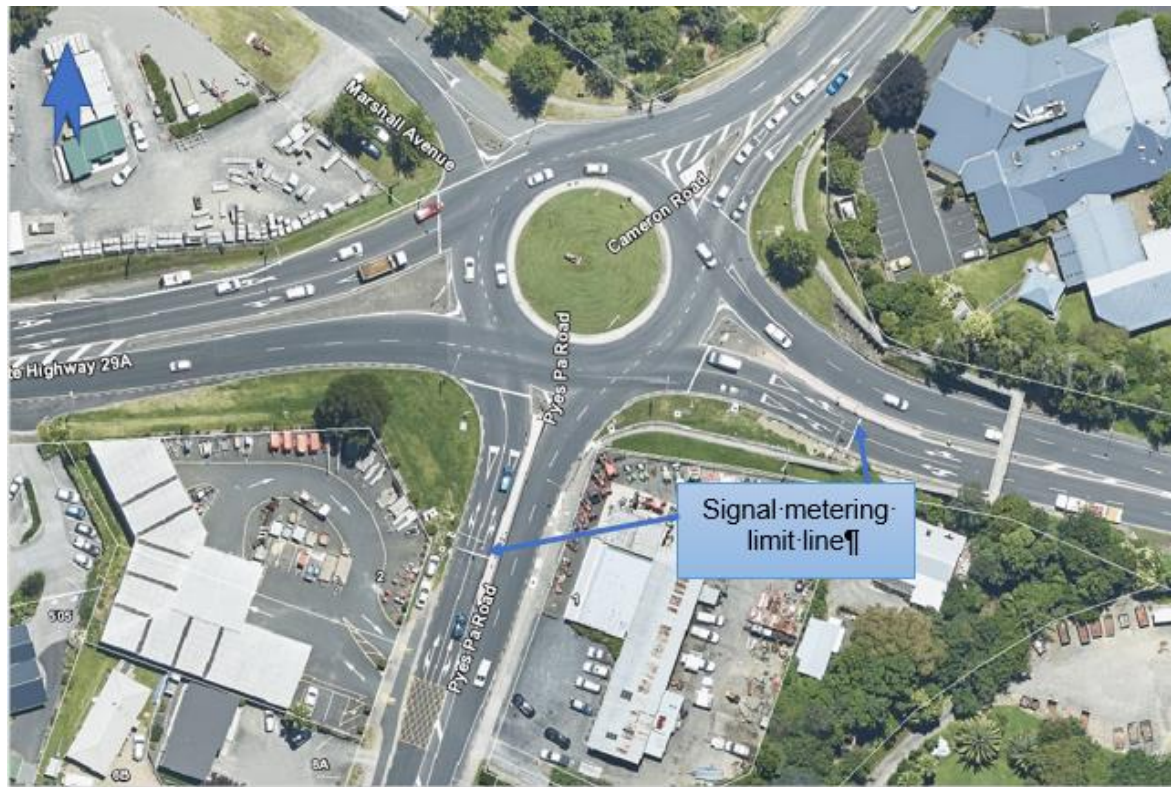
# Barkes Corner

For Barkes Corner, the first design was for three aspect metering signals, for the Pyes Pa Road northbound approach, to provide more through capacity for SH 29A eastbound traffic, to shorten the queue and relieve Takitimu Road Toll Road in the evening peak. Similarly, three aspect metering signals were designed for the SH 29A westbound approach to the roundabout to relieve queues on Pyes Pa Road in the morning peak.

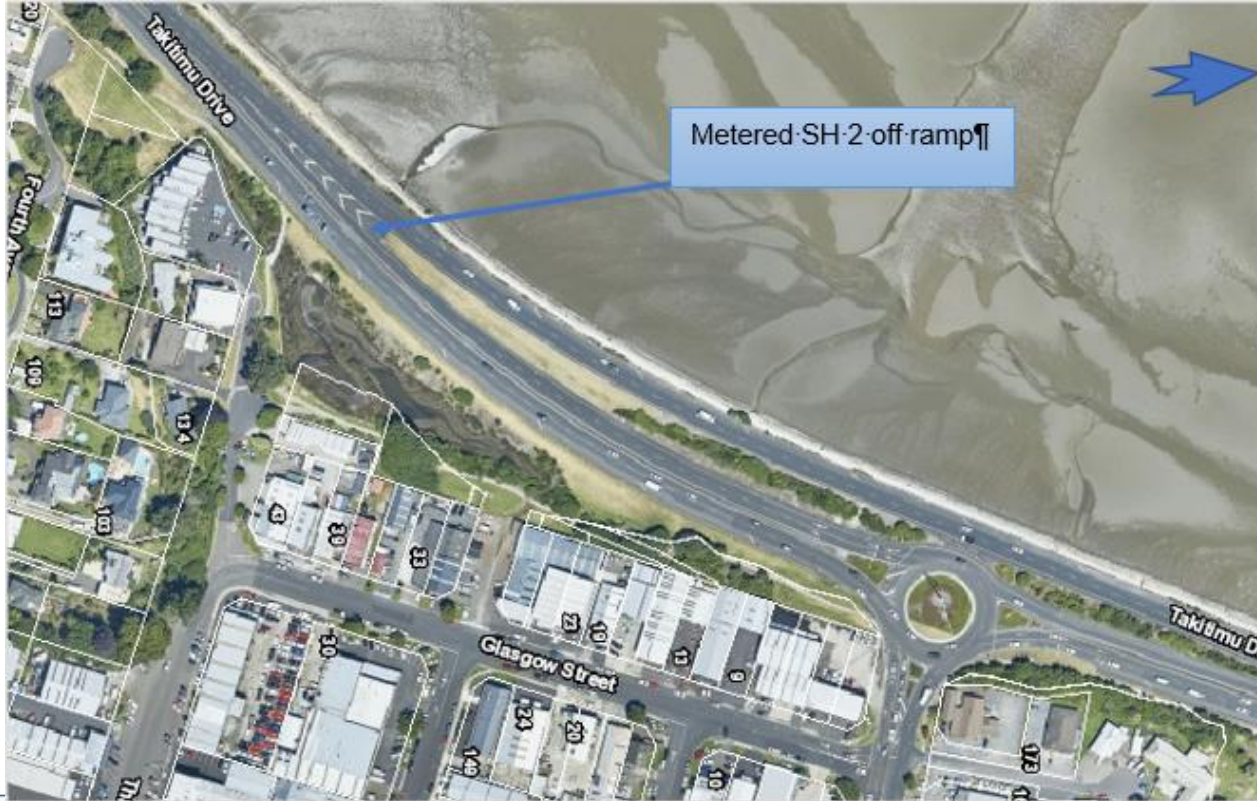
# SH2 Elizabeth Street

For Elizabeth Street metering signals were designed for the SH 2 off ramp to provide more through capacity for the SH 2 southbound traffic. The Elizabeth Street project included addressing evening peak queuing on Elizabeth Street, leaving the CBD via SH 2. Installing metering signal on this approach is currently on hold, awaiting Tauranga City network alterations.

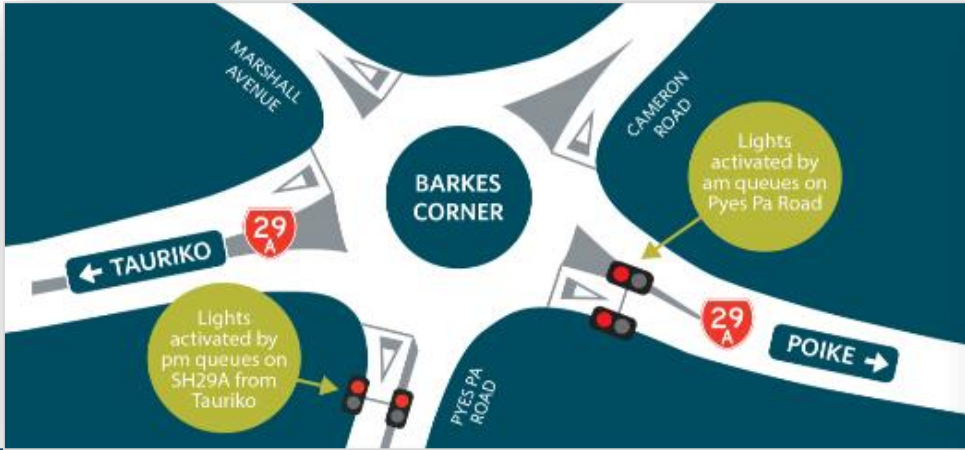
# Implementation and Operation

The two-aspect metering signals operate as follows:

- a steady yellow signal displayed for at least three seconds, followed by;
- a steady red signal, displayed for at least three seconds and timed to address the traffic delay issue, followed by;
- a blank display for at least three seconds, followed by the sequence commencing with the steady yellow, when appropriate;
- when metering is not required neither a yellow nor a red aspect is displayed.

- Two aspect signal (yellow and red);
- A green is not displayed at any time;
- When the NZ three aspect system displays green, in Australia there is no display. The driver sees nothing but a two-aspect display;
